Former Library at New Quay

Following a recent meeting between council officers in relation to properties held in trust, property services were asked to visit a vacant property formally used as New Quay Library. The reason for the visit is to get an understanding of its condition and potential for future use of the building / site.

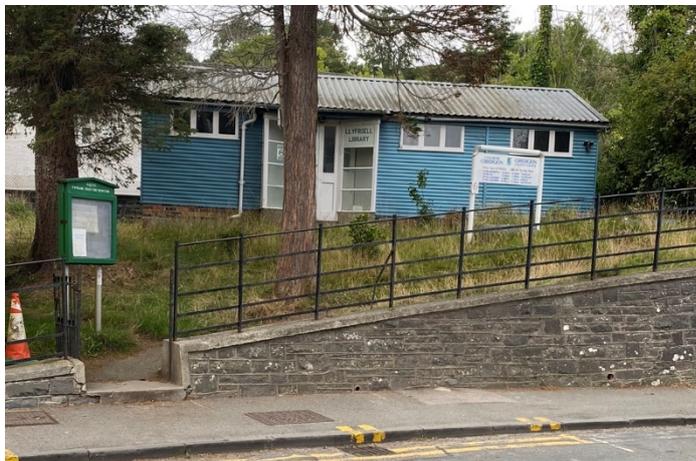
The site lies adjacent to B4342 with a time-controlled parking outside the site, a shop to the LHS facing and a fire station to the rear. Access to the site is via an unsecured gate and a ramped path, the path is steeper than any standard allows, therefore access does not and likely not meet the requirements of the Equality Act 2010 or Building Regulations, Approved Document M without substantial investment.

There are 2 mature trees which are a cause of concern to the neighbouring shop and has the potential to cause damage to either our building or the shop, although the trees appear to be in good health.

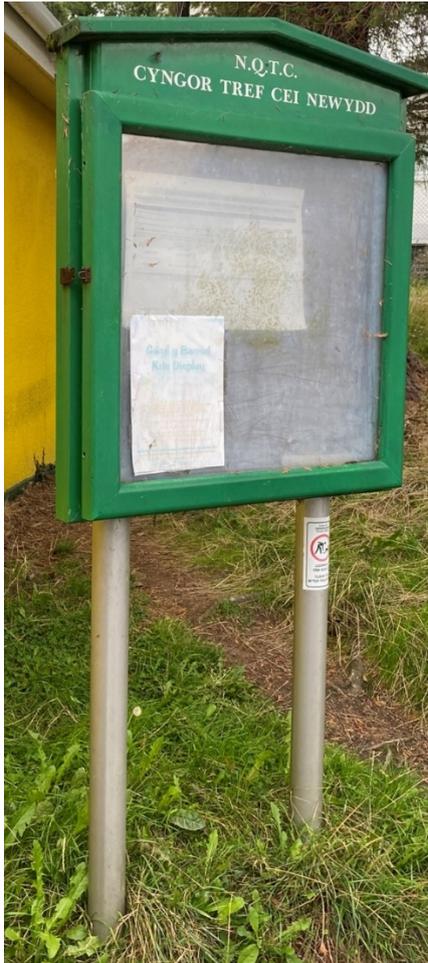
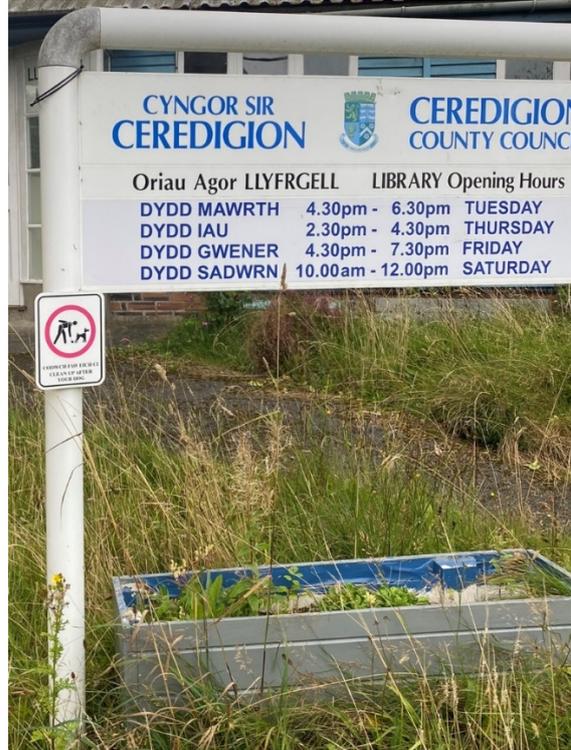
There is also a town council noticeboard and a library opening times sign visible from the roadside, both these signs invite people to enter the premises, adding to risks associated with void premises. Consideration needs to be given to remove these, especially the library opening times

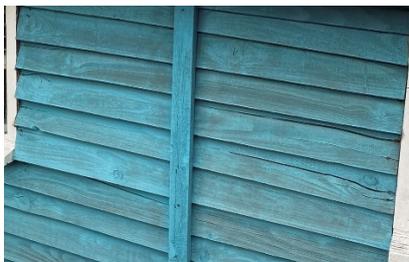
The timber cladding is generally in a fair condition, the lower sections show some degradation which is expected on a building of this age. Isolated areas of cladding show some natural timber shrinkage and cracking, especially around the fixings, which has the potential to allow water into the structure

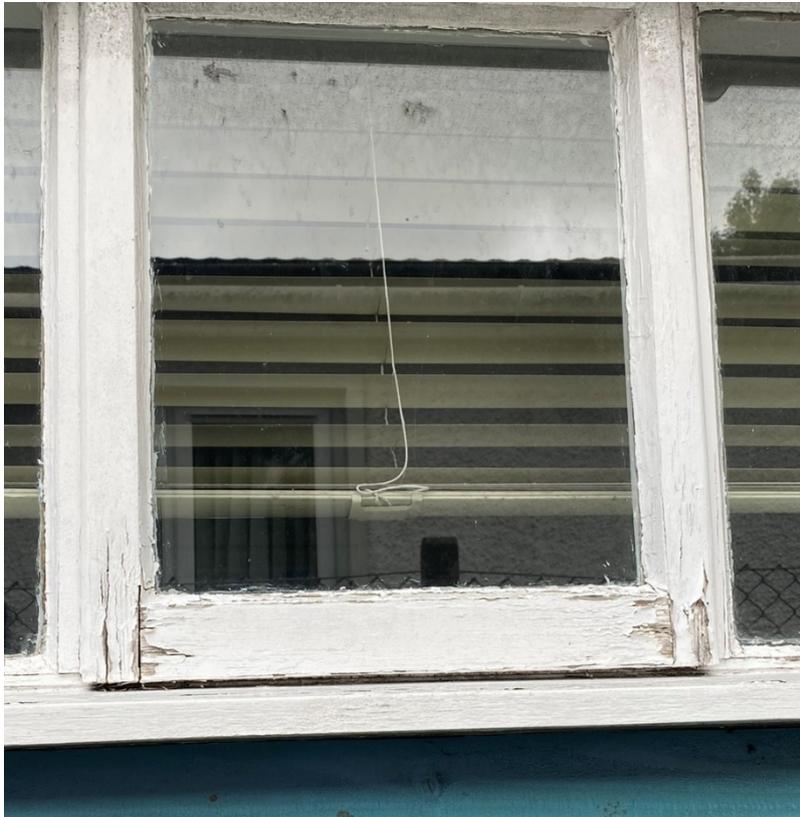
Windows is constructed of timber and are single glazed, some windows are showing decay which if left untreated will decay further, causing windows not having the

ability to be opened / closed. There is also an increased risk of the window failing and the glass falling out or again has the potential to allow water to enter the structure if repairs are not undertaken

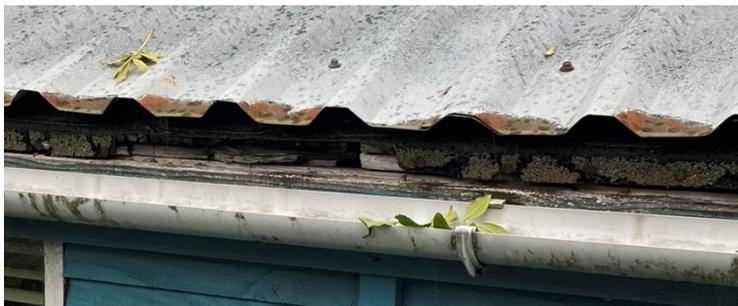
The roof looks to have been over cladded many years ago, the original construction being a felt flat or sloping roof. The cladded roof is in good condition, however the details at eaves appear to be poor, the original edge of the felt roof has rotted away and the guttering is relatively low, giving rise to significant risk of further decay.

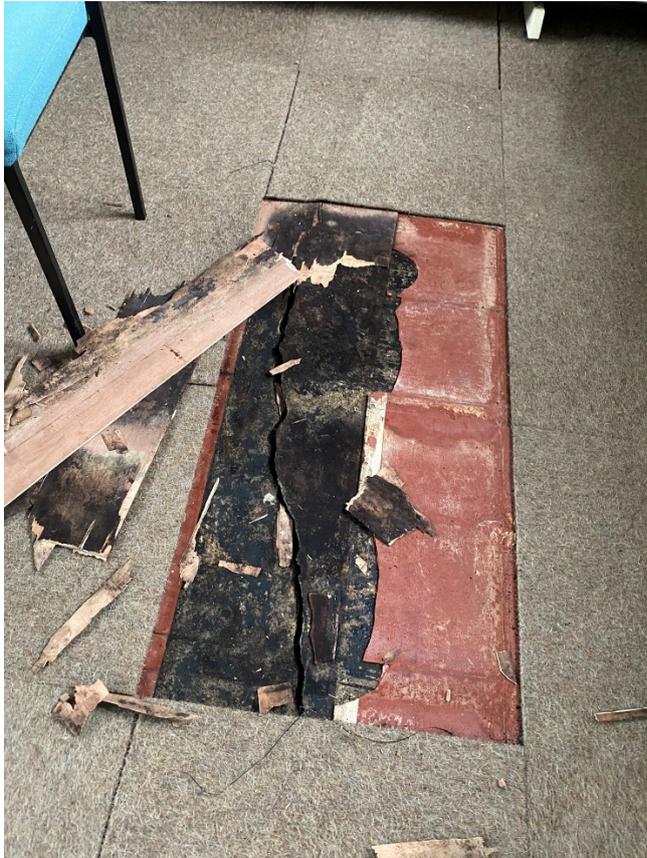
The internal walls appear to be in fair condition, although the shelves and some other items left hindered a full inspection. The floor is covered by carpet tiles, having removed the carpet in isolated places a crack greater than 10mm wide was seen, it

is unlikely that the floor is reinforced. BRE Digest 251 classifies cracks greater than 5mm as structural, requiring intervention.

The crack in the concrete floor will require significant repairs and I believe make any investment unviable without considering demolition and start with a blank canvas.
